Operating Experience Weekly Summary 97-06

February 1 through February 6, 1997

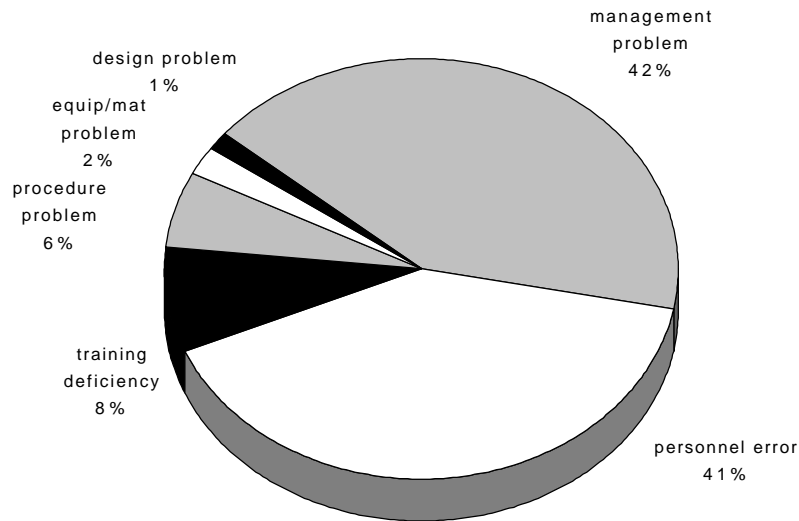
Operating Experience Analysis and Feedback (OEAF) engineers reviewed the Occurrence Reporting and Processing System (ORPS) database for nuclear criticality safety events caused by procedures not used or used incorrectly and found 140 events. Figure 1-1 depicts the distribution of the root causes of these events.

Figure 1-1. Distribution of Root Causes of Nuclear Criticality Safety Events with the Direct Cause of Procedures Not Used or Used Incorrectly¹

Management problems and personnel errors were the major contributors to nuclear criticality safety events caused by procedures not used or used incorrectly throughout the DOE complex. Table 1-1 shows the breakdown of each of the causal codes by percentage for each major area.

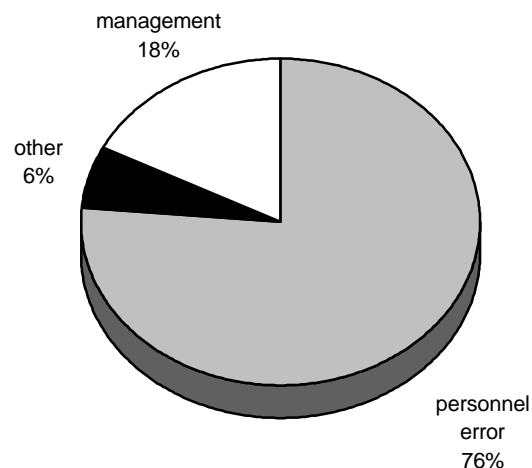
Operating Experience Analysis and Feedback (OEAF) engineers reviewed the Occurrence Reporting and Processing System (ORPS) database for all reports involving violations of radiological controls and safety postings. Figure 4-1 shows facility managers reported personnel error as the root cause for 76 percent of these events and management problems for another 18 percent.

Figure 4-1. Distribution of Root Causes for Violation of Postings¹

¹ OEAF engineers screened the ORPS database for reports using narrative violat@, radiation+radiological, posting@ and found 385 reports. A 100 percent review of these reports yielded 105 occurrence reports.
